THE CLIFF RUINS
OF
CANYON DE CHELLY, ARIZONA
BY
COSMOS MINDELEFF

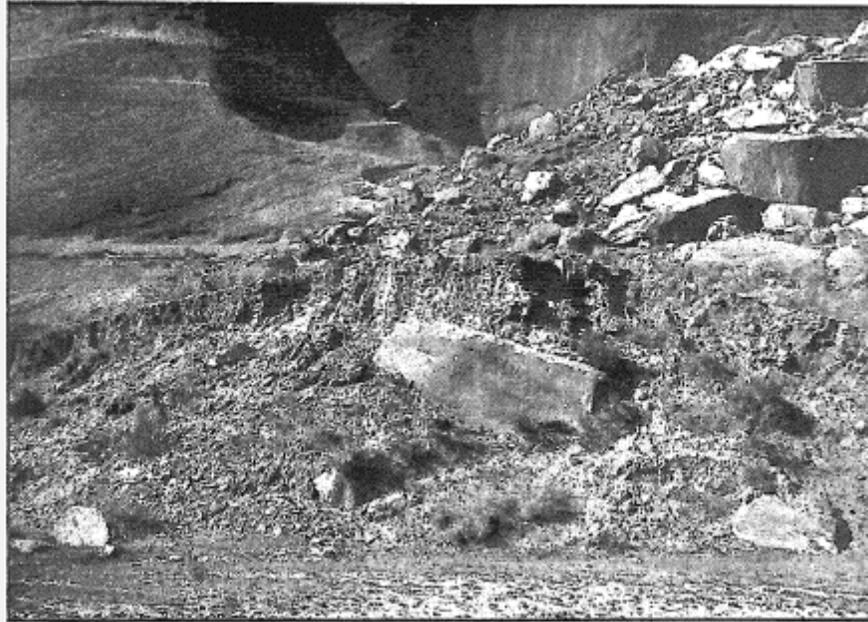
PLATE XLIV. SECTION OF OLD WALLS, CANYON DE CHELLY

If similar conditions prevailed in De Chelly, there might be many more ruins of this class than those so far discovered. Even those found are not easily distinguished and might easily be passed over. Possibly there were small ruins of this type scattered over the whole canyon bottom. An example which occurs at the point marked 12 on the map, and shown in [plate XLIV](#), presents no trace on the surface except some potsherds, which in this locality mean nothing. The site is a low hill or end of a slope, the top of which is perhaps 25 feet above the stream bed, but separated from it by a belt of recent alluvium carpeted with grass. The hill itself was formed of talus, covered with alluvium, all but a small portion of which was subsequently cut away, leaving an almost vertical face 15 or 18 feet high. In this face the ends or vertical

sections of several walls can be seen; one of them is nearly 3 feet thick and extends 4 feet below the present ground surface.

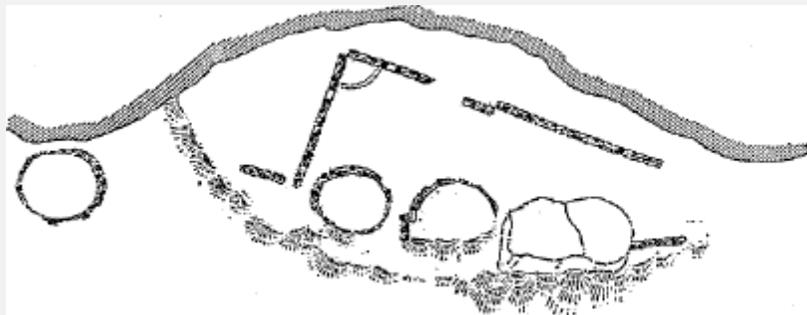
FIG. 10—Ground plan of a ruin in Canyon de Chelly.

Ruins of the class under discussion were not confined to any part of the canyons, but were located wherever the conditions were favorable. An example which occurs in the lower part of the canyon, at the point marked 3 on the map, is shown in plan in figure 10. It occurs at the back of a deep cove in a little branch canyon, and was at one time quite an extensive village. It was located on a slight slope or raised place next the cliffs and overhung by them. A stone dropped from the top of the cliffs would fall 45 or 50 feet out from their base. There are remains of three kivas. The central one, which was 12 feet in diameter, still shows nearly all its periphery, and the wall is in one place 3 feet high. The western kiva is now almost obliterated, but it can still be made out, and shows a diameter of 15 feet. It is 50 feet west of the central kiva and on a level about 8 feet below it, being only about 3 feet above the bottom land. East of the central kiva, and between it and a large boulder, there was another, of which only a part now remains.

North of the central kiva, and extending nearly to the cliff behind, there are remains of rooms. One corner is still standing to a height of 3 to 4 feet. The western wall was smoothly plastered outside and was pierced by a narrow notched doorway. The northern wall has an opening still intact, shown in [plate LVIII](#); it is 2 feet high and 14 inches wide, with a lintel composed of six small sticks about an inch in diameter, laid side by side. The sticks are surmounted by a flat stone, very roughly shaped and separated from them by an inch of mud plaster or mortar. The masonry is exceptionally well executed, that of the northern wall being composed of large stones carefully chinked and rubbed down. The chinking appears to have been carried through in bands, producing a decorative effect, resembling some of the masonry of the Chaco ruins. The western wall is composed of larger stones laid up more roughly with less chinking, and appears to have been a later addition. On the back wall of the cave are marks of walls showing a number of additional rooms, and there is no doubt that at one time there was quite an extensive settlement here.

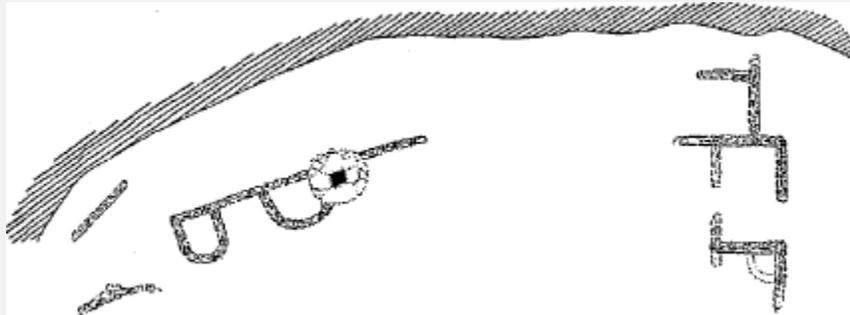
FIG. 13—Ground plan of a small ruin on bottom land.

There are a number of ruins in the canyons of the type shown in figure 13. They are generally located directly on the bottom, and seldom as much as 5 feet above it, within coves or under overhanging cliffs; they are always of small area, and generally so far obliterated that no walls or wall remains are now visible. The obliteration is due not so much to antiquity, which may or may not have been a cause, but to the character of the site they occupied. They are always in sheltered situations, and being

The example illustrated occurs at the point marked 43 on the map. It is situated in a cove in a point of rock jutting out from the main cliff. The rock is about 60 feet high and the cove about 30 feet deep, and the remains are but a few feet above the level of the bottom land outside. The walls are composed of rather small stones; the interstices were chinked with [spawls](#), and the masonry was laid up with an abundance of mud mortar. The back wall of the cove is considerably blackened by smoke.

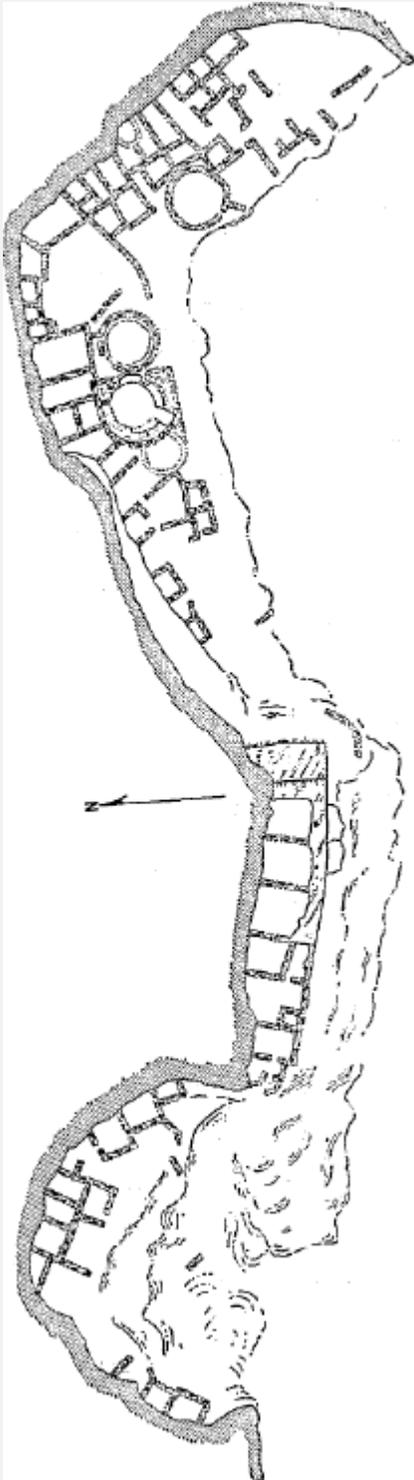
FIG. 16—Ground plan
of Mummy Cave ruin.
[Horizontal View](#)

The rooms in the western cove are fairly uniform in size and were probably habitations, for they are all too large to be classed as storage rooms. There was no kiva in this portion, however, nor any unoccupied place where a kiva might have been placed. It seems clear, therefore, that this portion was either an appendage of the other or was occupied at a later period; in either case it was constructed at a date subsequent to the remains in the eastern cove.

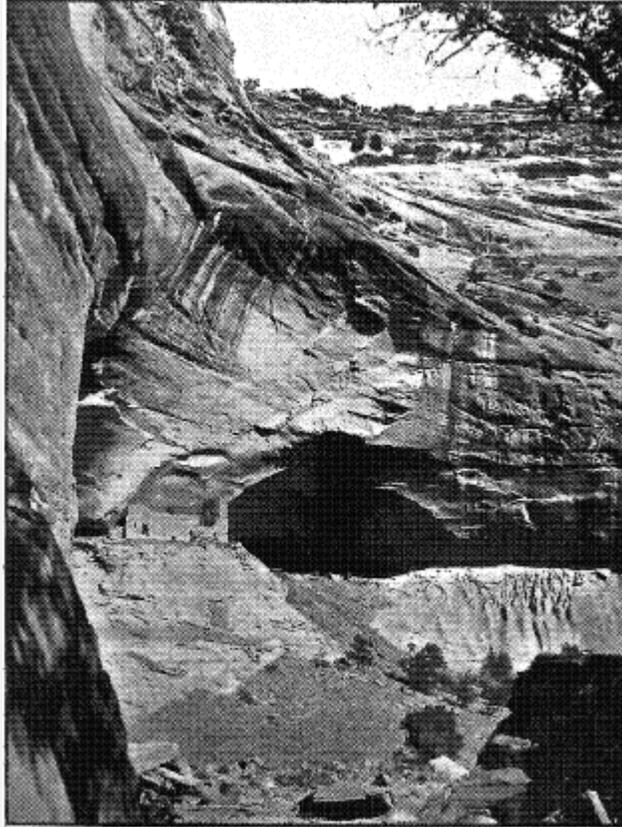
PLATE XLVIII. MUMMY CAVE, CENTRAL AND EASTERN PART

The doorway mentioned is the only opening into the ground-floor room in the tower. Connection with the rooms on the west was through a large doorway in the western wall of the second story, and in the story above there was a similar opening. These are shown in plate XLVIII, which is a general view of the central portion of the eastern cove.

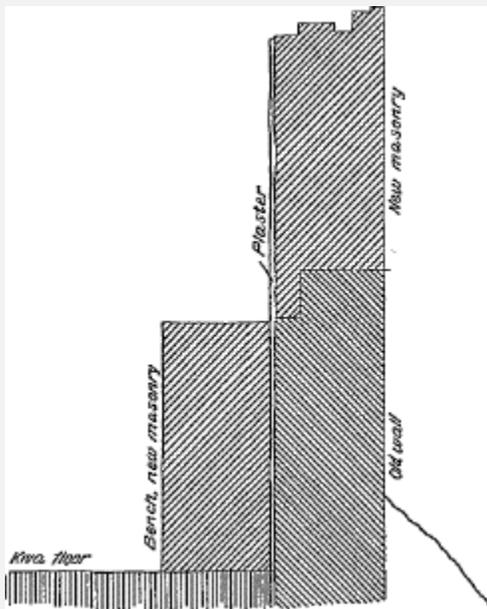
FIG. 22—Section of a kiva wall.

122 There is a suggestion in this that the site of the kiva was originally occupied by rectangular rooms, and there is a further suggestion, in the end sections referred to, that the kiva had at some period fallen into decay and was subsequently rebuilt. All this occurred before the first falling out of the front.

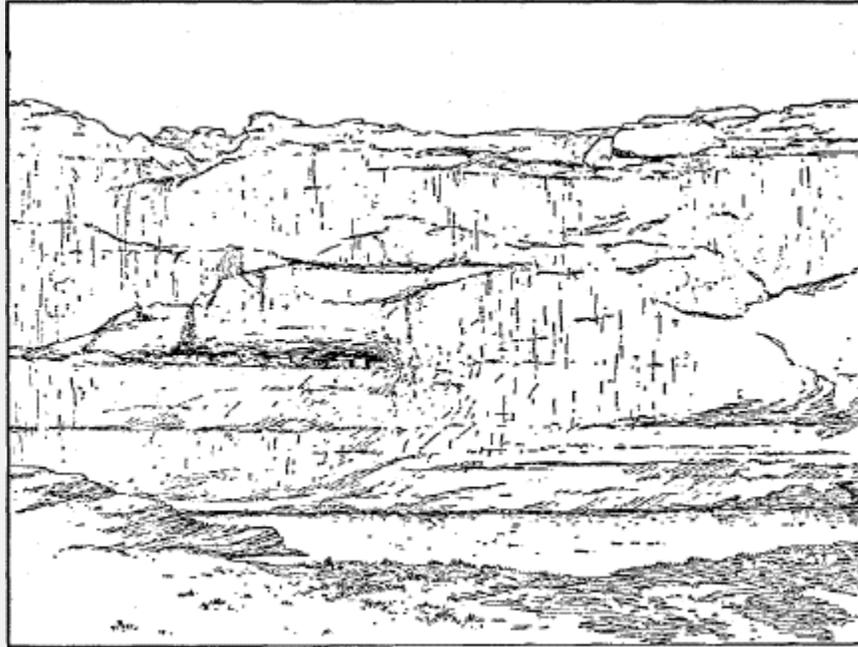
FIG. 23—Ruin No. 10 on a ledge in a cove.

Figure 23 shows the character of site occupied by a village ruin of some size situated in the first cove in the cliff wall below the mouth of Canyon del Muerto. The cliff here is about 300 feet high and the ruin is located on a ledge in a cove about 70 feet above the stream bed. Although seemingly very difficult to reach, the ruin is of comparatively easy access without artificial aid. The cavity was caused apparently by the occurrence of a pocket of material softer than that about it, and this softer material has weathered out, showing very strongly the lines of cross bedding, which, in the massive rock on either side, have been almost entirely obliterated. The strata are inclined at an angle and the edges project from a few inches to about a foot, forming a series of little benches tilted up at an angle of about 45 degrees. By the exercise of some agility, one can ascend along these benches. About halfway between the site of the ruin and the stream bed there is a narrow horizontal bench, and again halfway between this bench and the ruin there is another, about 55 feet above the stream. Access to the ruins is greatly facilitated by these intermediate ledges.

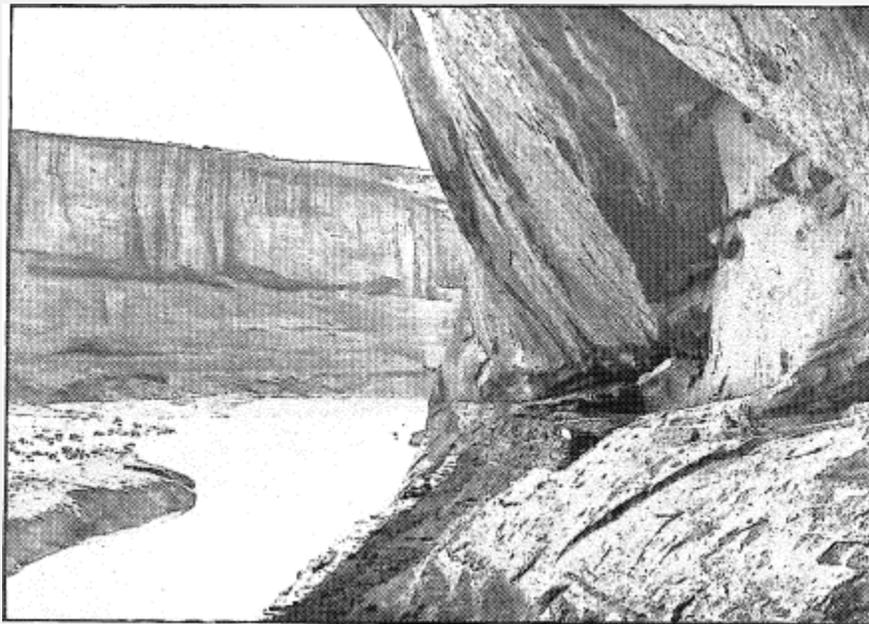
PLATE L. RESERVOIR IN RUIN NO. 10

The western end of the ledge was occupied by a structure whose use at first sight is not apparent. The wall, as shown on the plan, is curved, very thick and heavy, and built partly over the sloping rock forming the back of the cave. The front wall is 3 feet thick, and its top, now level, is about 5 feet above a narrow bench in front of it. There is no doorway or other opening into it, and access into its interior was had over the steep sloping rock to the north by means of hand-holes in the rock. These are shown in plate L. The interior appears to have been plastered.

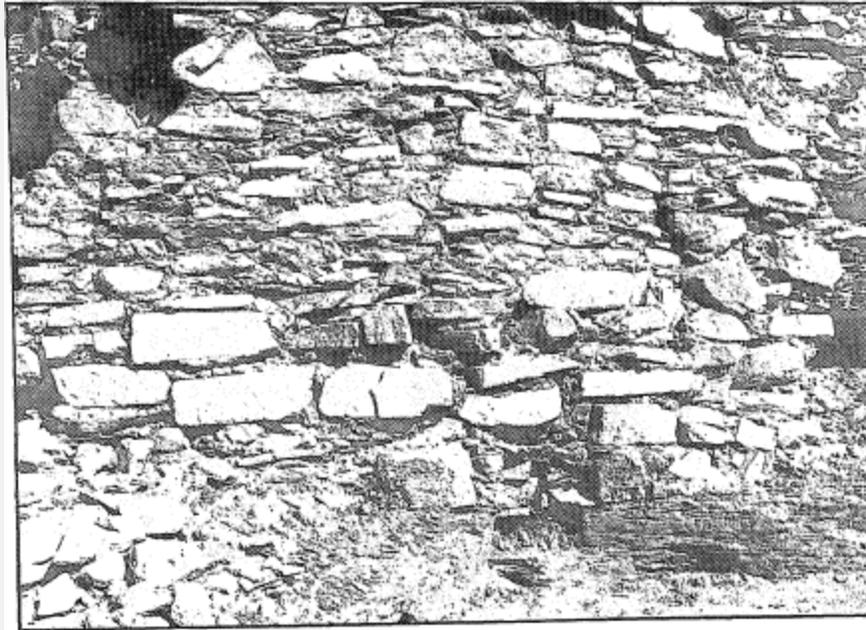
PLATE LII. WALLS RESTING ON REFUSE IN RUIN NO. 16

plate LII, which shows also the débris, consisting of ashes, sheep dung, and refuse, well compacted, upon which the wall rests.

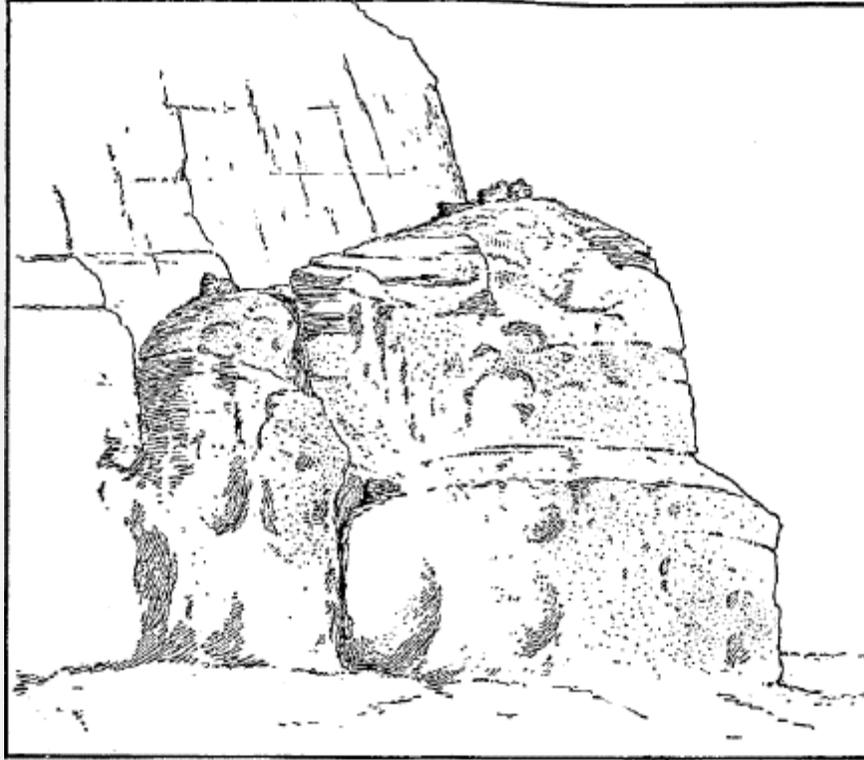
FIG. 28—Ruins on a large rock.

A type of site which is abundant in the San Juan country and is found in other regions, but is very rare in this, is shown in figure 28. ¹³¹This example, which occurs in the upper part of Del Muerto, is the only one of its kind in the canyons. A large mass of rock, smoothed and rounded by atmospheric erosion, but still connected with the cliff at one point, juts out into the bottom, a large area of which is commanded by it. At three different levels there are remains of rooms, the group on the summit being the largest. It is doubtful whether any of these remains represent permanent villages, but it is possible that the uppermost one did. It is therefore included in this place.

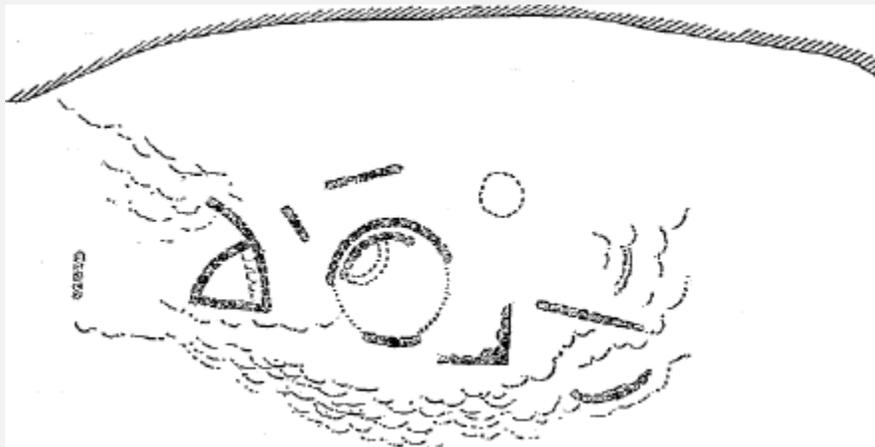
FIG. 36—Ground plan of a small ruin, No. 44.

Figure 36 is the ground plan of a somewhat similar ruin which occurs at the point marked 44 on the map. It is situated on the top of the talus, against the cliff, and commands a fine outlook over the cultivable lands in the cove below it and on the canyon bottom proper. There are but few wall remains, but two kivas can still be made out. There is no ledge here, and the walls were built on loose debris of rocks and talus. The builders had some trouble in holding the walls in place, and only partly succeeded in doing so. About one-half of the principal kiva is standing, showing masonry composed of exceptionally large stones, roughly chinked. The other, or western kiva, was similarly constructed, and both had interior benches. The front of the western kiva fell out, the builders being unable to tie it or to hold it in place on its loose foundation, and other walls were constructed inside of it, as shown on the plan. There were other walls outside the main kiva, apparently rectangular inclosing walls. This example is interesting because the masonry was constructed on a foundation of loose debris, not on bed rock, and the knowledge possessed by the builders was not sufficient to enable them to overcome the natural difficulties of the site. ¹³⁸Although ultimately the village had to be abandoned as a failure, it was certainly occupied for some years, and this occupancy suggests that there was some strong objection to the lower part of the canyon. It illustrates, moreover, the importance which was attached to a command or outlook over extensive cultivable areas, as to obtain such an outlook the builders were content to occupy even such an unsuitable site as the one described.

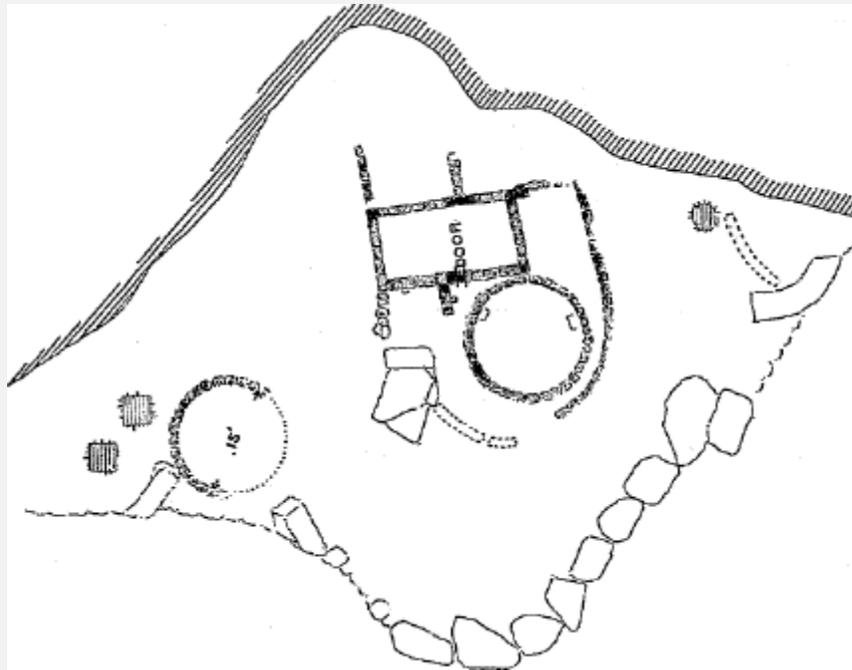
FIG. 39—Ground plan of a ruin in Canyon de Chelly.

Figure 39 shows a ruin where the site was not so restricted. One well-defined room and two kivas still remain, and there are traces of other chambers. The main kiva formed part of a compact little group of rooms, of which it occupied the front, and appears to have been inclosed by a curved wall of rough construction. A curved inclosing wall is an anomalous feature, and it is not at all certain that it occurs here, as the wall is so much broken down that its lines can not now be clearly made out. Excavation would doubtless determine this, as the whole site has been much filled up with sand and loose earth.

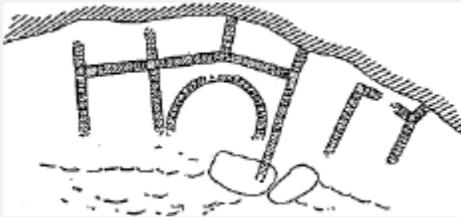
FIG. 42—Ground plan of a small ruin in Canyon del Muerto.

Figure 42 is a ground plan of a small ruin in Del Muerto in which the usual preponderance of rectangular rooms is illustrated. The site was restricted, but there is an apparent attempt to carry out the usual arrangement of a row of rooms against the cliff, with a kiva in front. Probably only three of the rooms shown were used as habitations. The plan of the kiva, which occurs in the center, was somewhat marred by a large boulder, which must have projected into it, but apparently no attempt was made to dress off the projecting point.

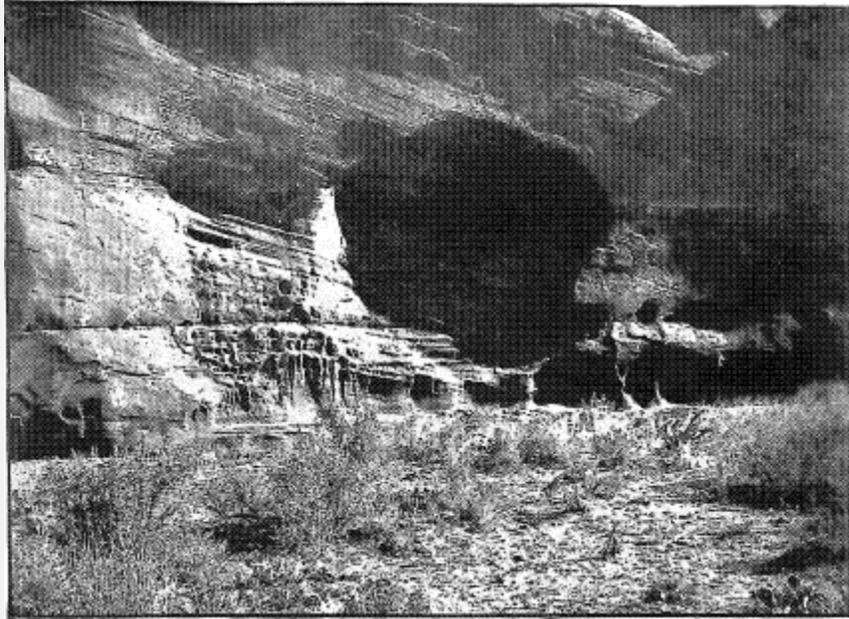
PLATE LIV. CLIFF RUIN No. 14

The masonry is fair and the surface is finished with plaster. The open space in front of the small back room and the outer wall of the room itself are much blackened by smoke, as though the inhabitant lived here and used the small room only to store his utensils and implements. A small room on the east must have been used for a similar purpose. Both of these rooms were entered through narrow doorways opening on the principal space. The site is an ideal one for a lookout, but not well suited for a habitation. Plate LIV shows its character.
